# AN ELECTRON ACCELERATOR ACCIDENT IN HANOI, VIET NAM

INTERNATIONAL ATOMIC ENERGY AGENCY  
VIENNA, 1996

Nevertheless, on occasions safety systems or procedures are ignored or bypassed and serious radiological consequences ensue. On 17 November 1992 one such event took place at an electron accelerator facility in Hanoi, Viet Nam. An individual, entering the irradiation room without the operators' knowledge, unwittingly exposed his hands to the X ray beam. His hands were seriously injured and one had to be amputated.

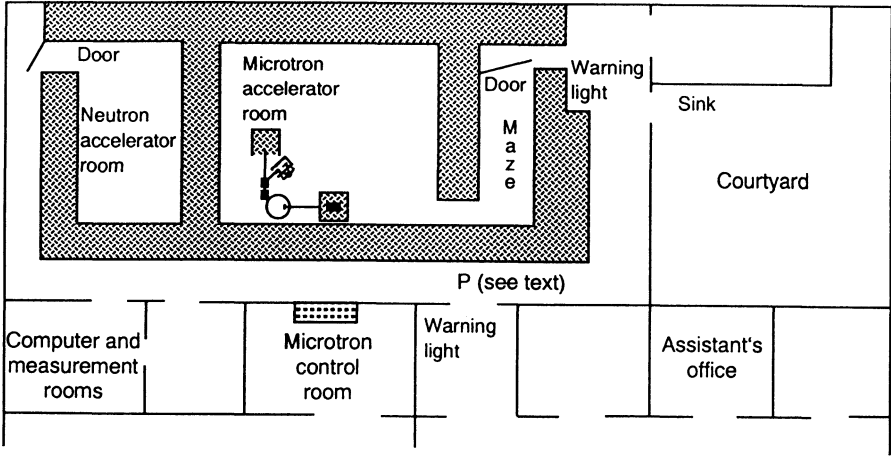
FIG. 4. Schematic diagram of accelerator facilities and offices at the Institute of Nuclear Physics.

After positioning the second sample close to the tungsten target, they left the accelerator room and walked towards the control room. When they were halfway there (Fig. 4, position P), the director asked one assistant to get him some soap and he turned around as if to head towards a sink outside in the courtyard. The assistant, having to pass close to the control room to get the soap, told the operator that the experiment was ready and the machine could be switched on.

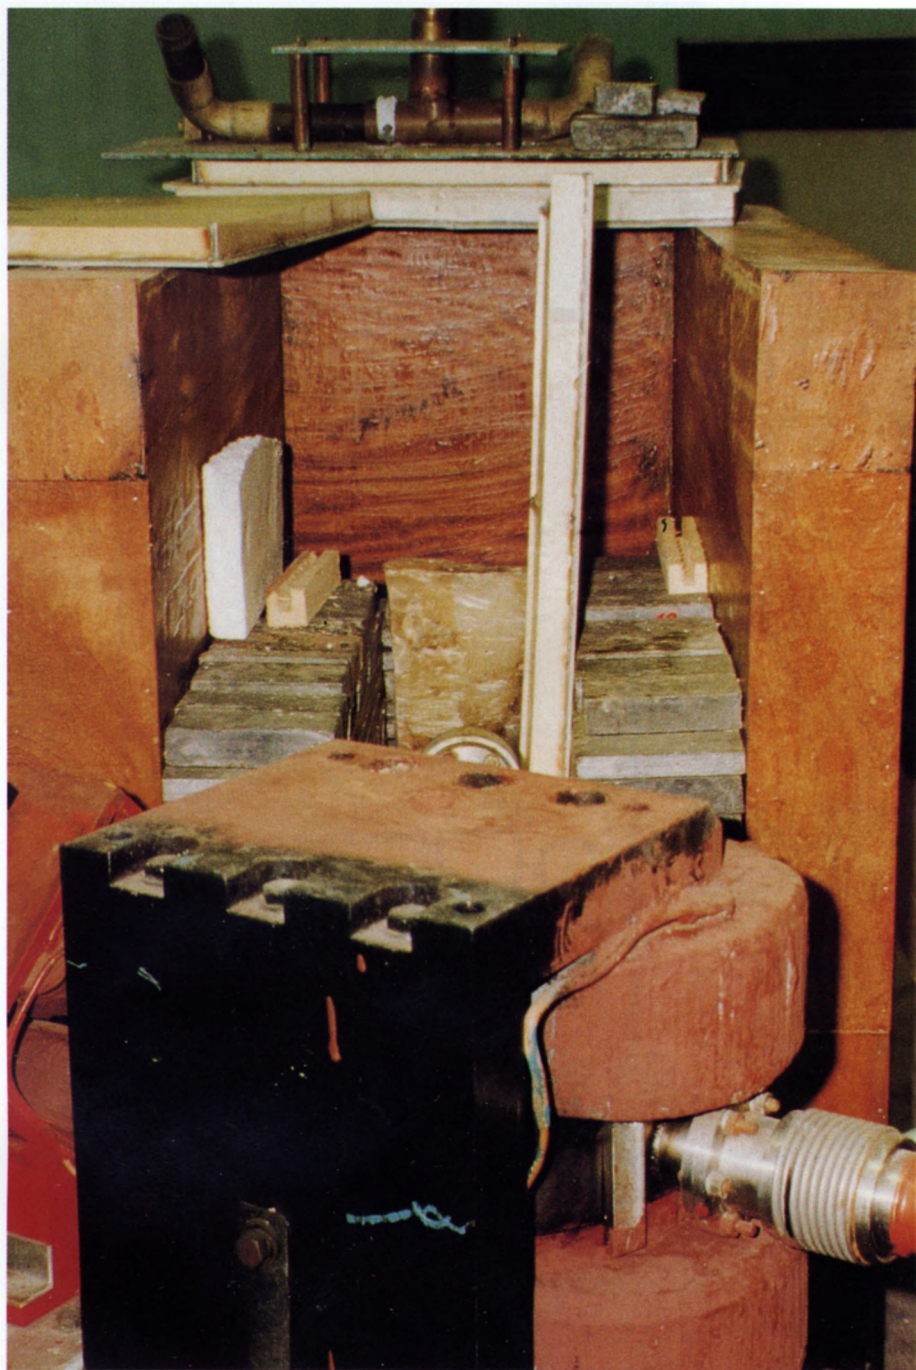
PLATE 1. General view of accelerator room equipment.

A general view of the accelerator room is shown on Plate 1. The MT-17 accelerator operates on principles similar to those of betatrons, accelerating electrons in a circular orbit and directing them to an appropriate target material. It is fitted with two guide tubes, one with a tungsten target to produce X rays and the other with a uranium target to produce neutrons. (A schematic diagram of the equipment is given in Fig. 5.) At the time of the accident, the electrons, accelerated to 15 MeV, were directed through a horizontal guide tube into the 2 mm thick tungsten target, producing a conical ( $6^\circ$  solid angle) X ray beam for use in a ( $\gamma,n$ ) activation experiment. The beam current was variable and at times had been run up to 16  $\mu$ A but the maximum attainable

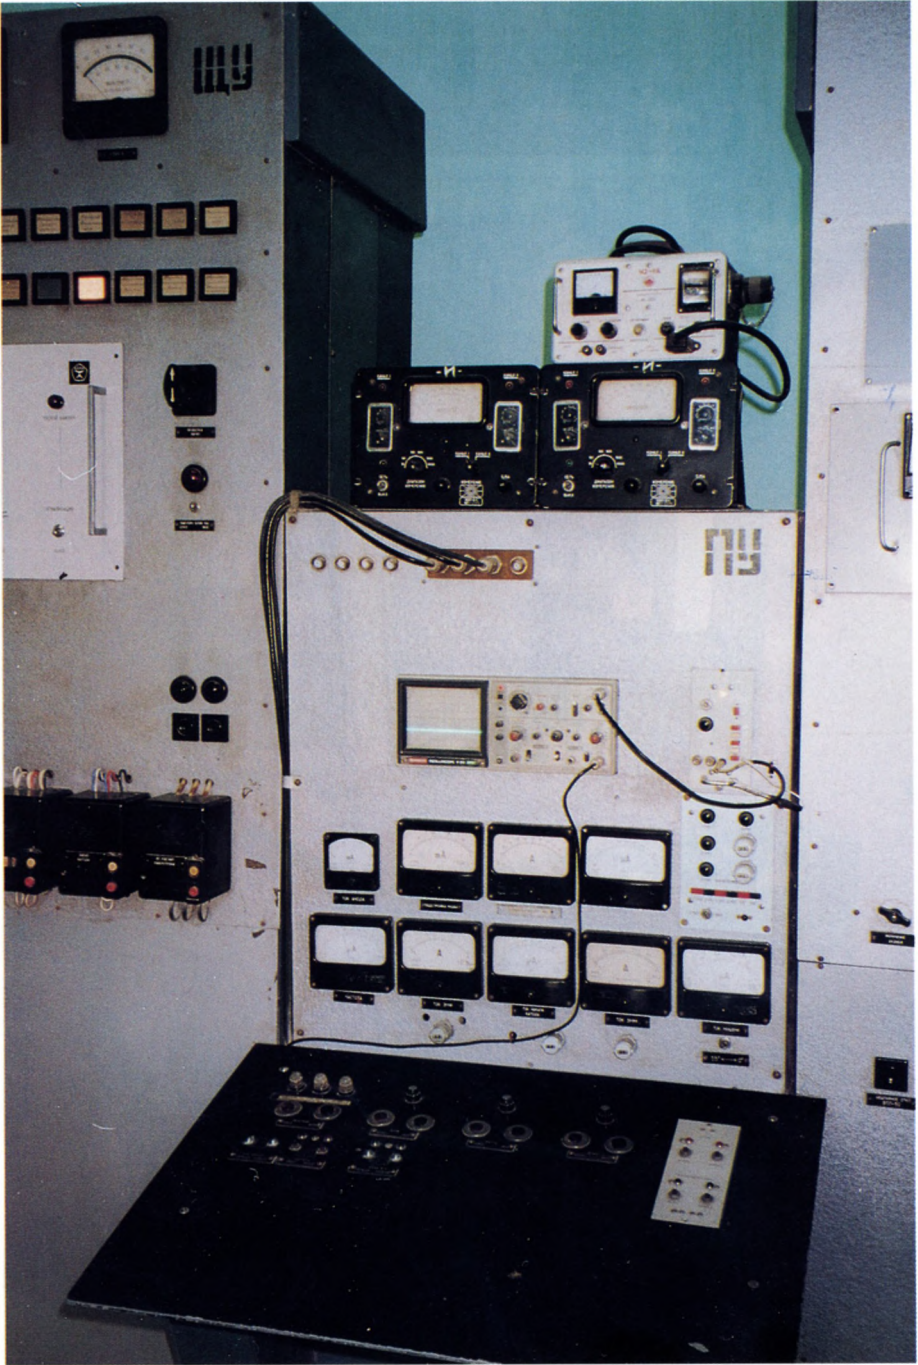
PLATE 2. Control console for the MT-17 accelerator at HINP.

**Control console and its operation.** The control console (Plate 2) has no master key, but it was considered unlikely that the machine would be used by unauthorized persons, as all the controls were labelled in Russian. Moreover, the switch-on procedure is complicated:

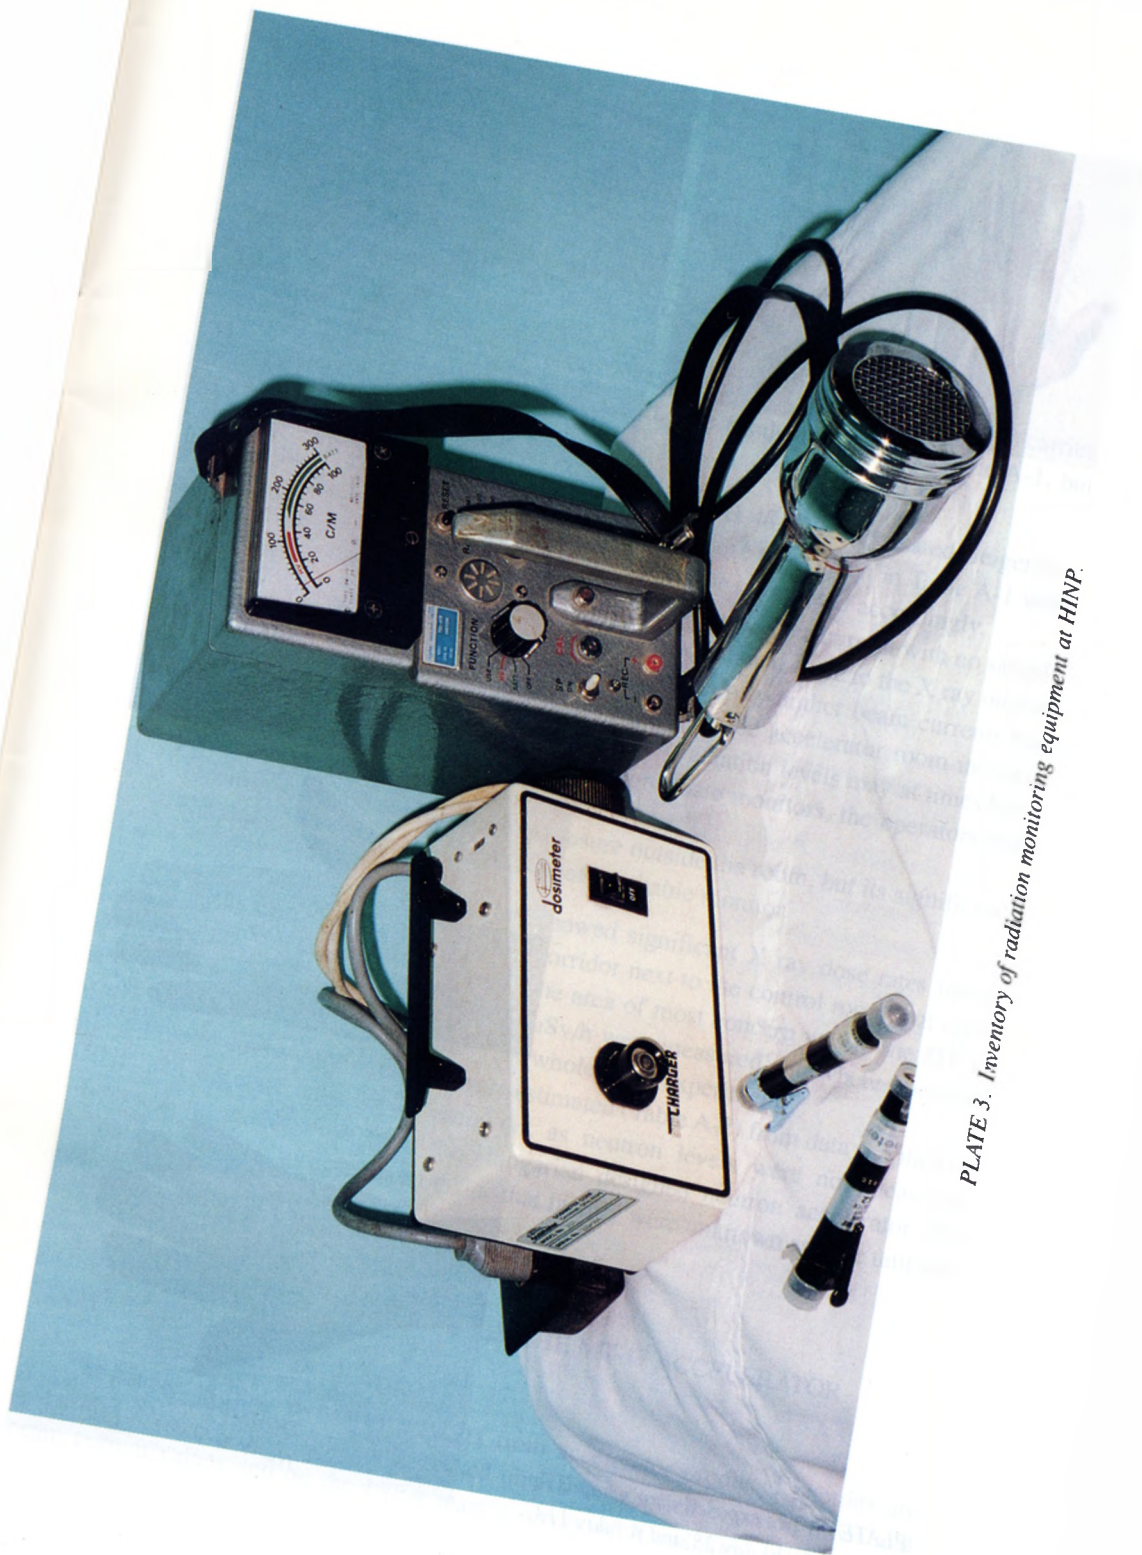
PLATE 3. Inventory of radiation monitoring equipment at HINP.

**Radiation monitoring.** The output of the single radiation detector (in the maze) was in counts-per-second and the system was not calibrated. Thus, it did not give quantitative dose rate information but merely indicated the presence of radiation. At the time of the accident the total inventory of portable radiation monitoring equipment at the Institute consisted of a single end-window Geiger tube connected to a ratemeter scaled in counts-per-minute, and two quartz fibre electroscopes, neither of which had been calibrated (Plate 3). Owing to lack of equipment and training, no radiation monitoring had ever been done outside either of the accelerator facilities.
